Coastal Erosion and Coastal Structures in Clifton Hill Beach, Point Fortin, Trinidad

ABSTRACT

This paper deals with the study of coastal erosion along the Clifton Beach, Point Fortin, Guapo, the southwest coast of Trinidad. It also deals with the effectiveness of coastal structures that have been built along the beach. In spite of the coastal structures that were built one after the other, erosion could not be prevented; only the area of erosion has been shifting along the coast in the northeasterly direction.

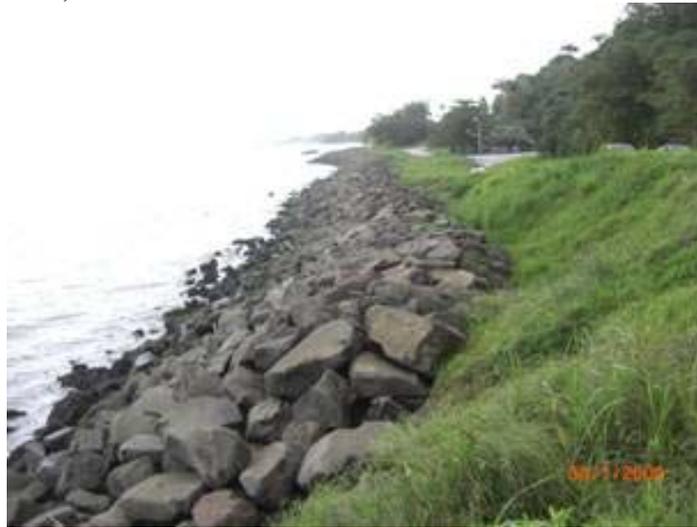
Figure 3 – 460m long stone revetment

Initially, on the southwestern part of Cifton Beach, Point Fortin erosion was observed during 2002. A stone revetment of 460m was undertaken during March 2003 and November 2004 (fig. 3) in that area to prevent erosion. The basalt stone required for the revetment was brought from St. Lucia. By the time of completion of the revetment, it was found that erosion shifted further northeast of the revetment. It continued for five years. The

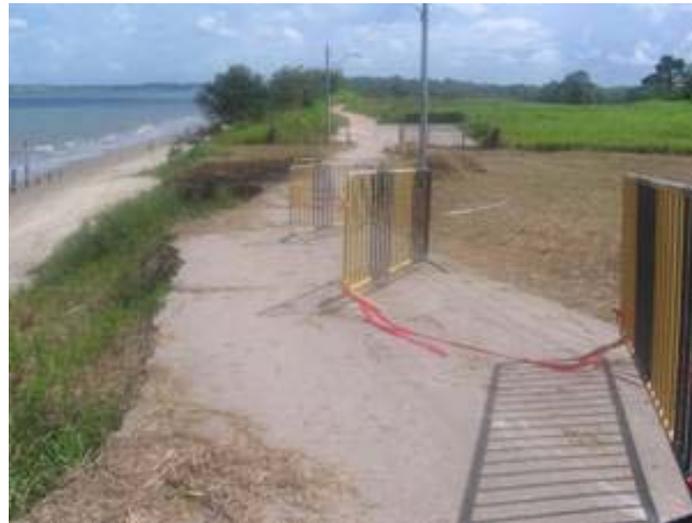
Figure 4 – Erosion at Clifton Beach, Point Fortin,

old existing road was totally damaged and in its place a steep cliff with a height of around 10m from the water level formed (fig 4). The old road that was brought down can be seen at present on the beach (fig.5). The original slightly convex (towards the sea) road has become concave. The retreat of the beach was up to 15 to 20m.

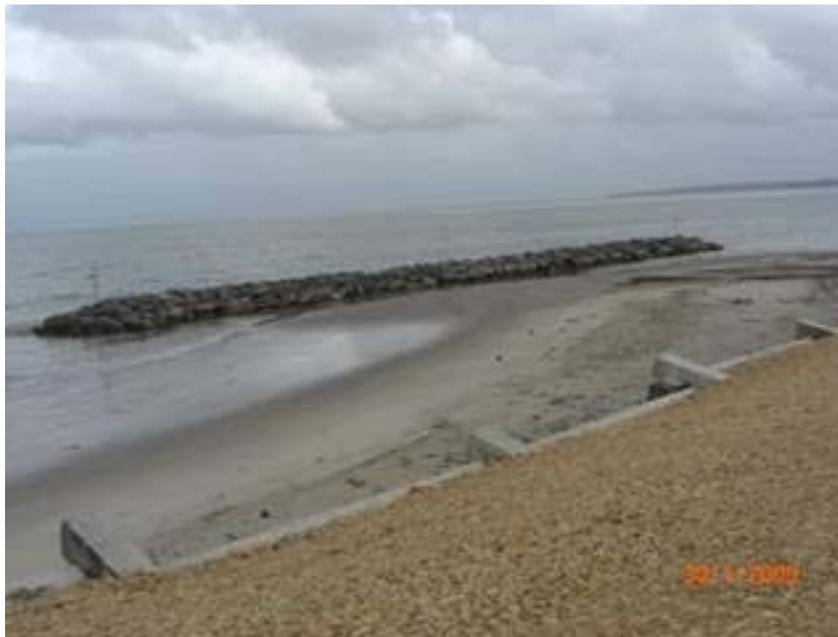
Figure 6 – Cribwall and a breakwater

As it had been severely eroding, first a break water (fig.6) was taken up to facilitate construction of protective structures to protect further erosion. At the time of constructing the breakwaters, the water depth was more than 2m, but now the area has been silted. The sheet piling and a crib wall supported by stone revetment (fig.7) was completed in November 2008. The crib wall is to a length of nearly 200m. And a new road was laid after these protective measures were taken. The structures could serve their purpose as expected.

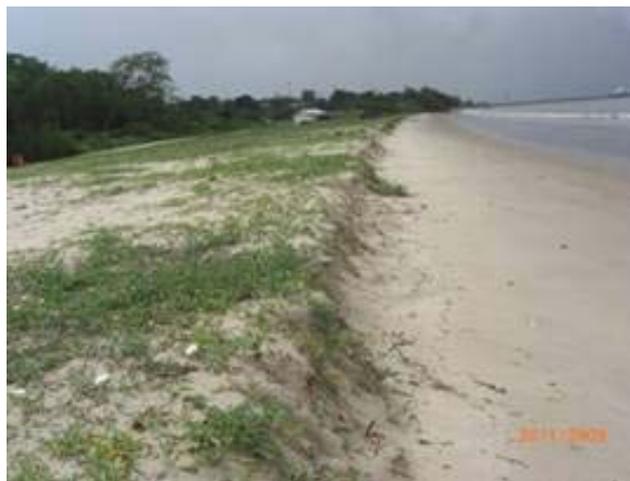
Figure 8 – beach erosion

But erosion on the beach could not be stopped. It only shifted to further northeast as can be seen in the fig.8. The backshore with vegetation is cut and the height of the berm is about a meter.
