Design, Construction, and Test of a Postensioned Segmental Beam

ABSTRACT

This paper describes the construction of a 21'4" postensioned segmental beam and its respective loading test. The segments were two solid end blocks and nine hollow blocks, all of them were cast using high strength lightweight concrete, poured on a metal form. The postensioning was performed according to the design plan so as to control the deflections produced by the postensioning of each strand. Two strands were located along the bottom of the beam, another strand was located along the center, and a fourth half-loaded strand ran along the top of the beam. The segmental beam was tested to failure by applying a load at the center of the beam. The strains, deflections, and the ultimate load obtained during the tests match well with the theoretical predictions.

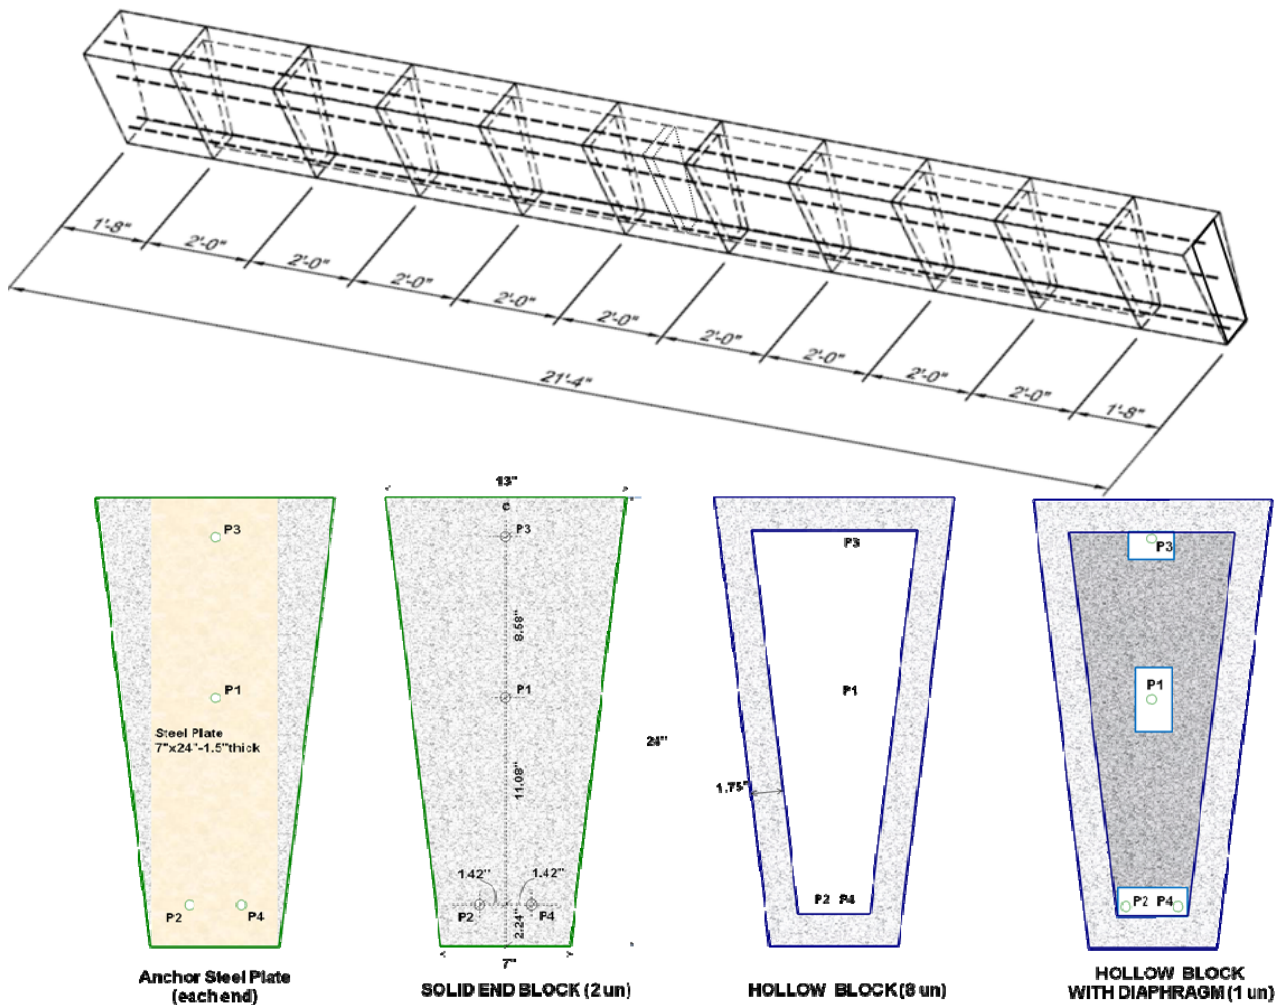
Figure 1. Segmental beam dimensions

Figure 1 shows the drawings for the segmental beam, consisting of two solid end blocks 20" long, eight hollow blocks 24" long, and one hollow block with a transversal diaphragm, resulting in a total length of 21'4". The beam had a trapezoidal cross section 2'0" height, and widths of 13" at top and 7" at bottom. The hollow sections had 1.75" uniform wall thickness, which were obtained using a styrofoam block properly spaced from the form.

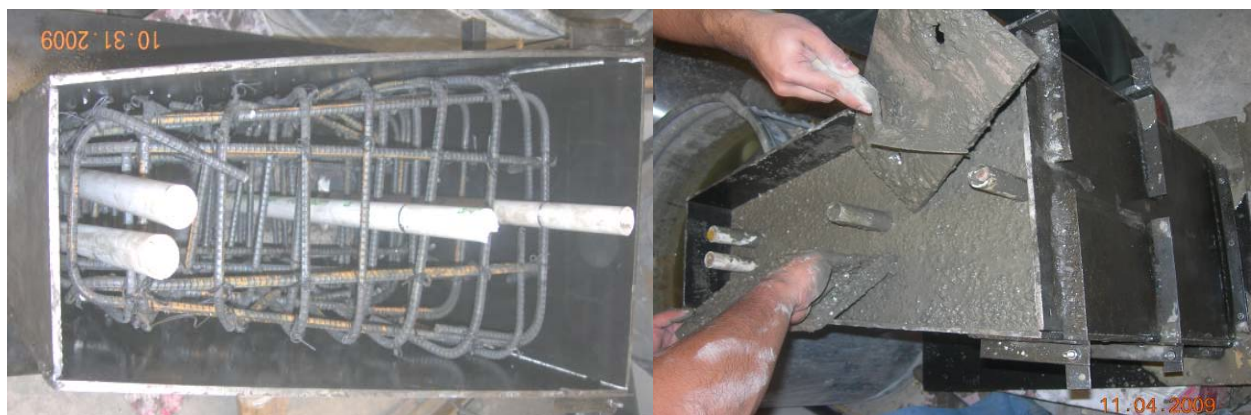
Figure 2. Construction of the solid end blocks

Figure 2 shows the #3 stirrups used to resist the bursting forces from the postensioning, and the pouring of the end solid blocks. A steel plate of 7"x24"x1.5" was used to receive the anchors. Figure 3 shows the reinforcement of the hollow segments consisting of wire mesh of 2"x2"x0.12". The styrofoam block was removed after curing.

a) Anchor steel plate, pipes to install the strands, and rebar inside the form (2.2 in² vert., 3.3 in² hor., and 1.32 in² long.)

b) Concrete pouring verifying that the pipes are in the correct position.

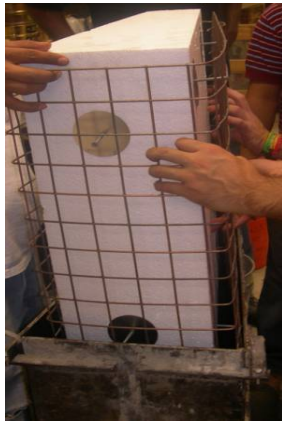
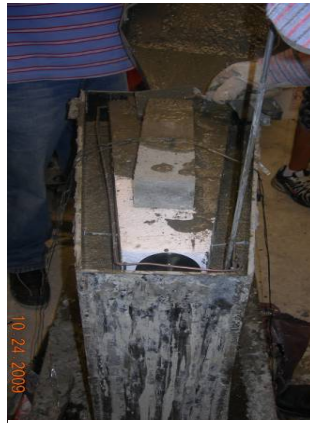
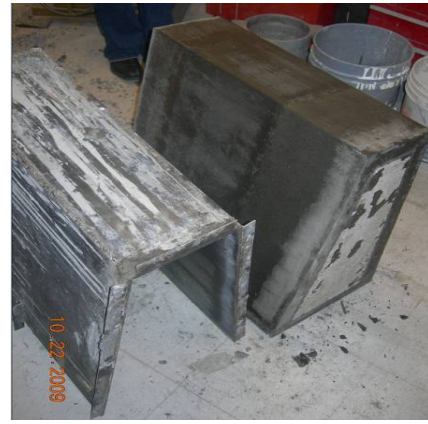
Figure 3. Construction of the hollow segments

a) Styrofoam block, welded wire mesh and spacers

b) Concrete pouring and segment after form removal

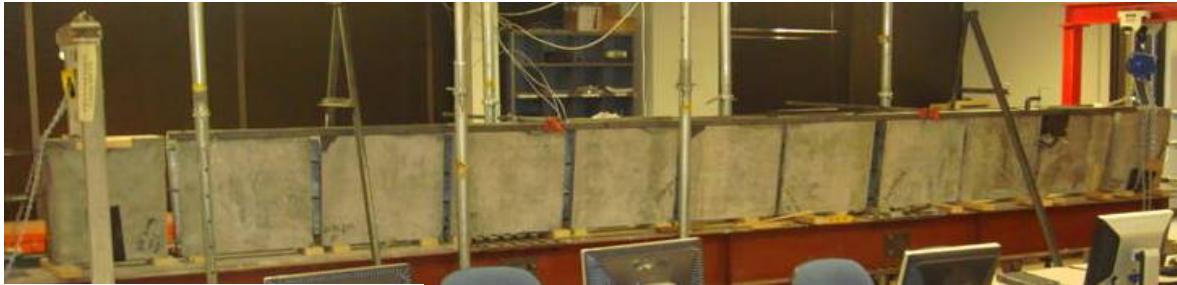
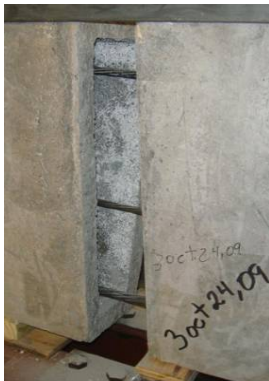
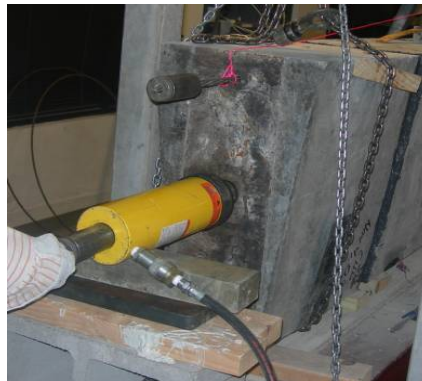
Figure 4. Construction of the segmental beam: alignment, epoxy and jacking of central strand.

Figure 4 shows the process for making the beam using the segments, strands, and epoxy. The segments were aligned over the testing beam maintaining a space between segments of 1" to permit the application of the epoxy. The epoxy paste PC-7 had a working time of 1 hour and setting time of 24 hours. The main use of the epoxy paste was to provide a uniform contact surface avoiding stress concentrations during posttensioning. The epoxy was applied over dirty surfaces, and then it cannot resist tension stresses. The segments were joined stressing the central strand P1 until 28 kips.

a) Alignment of the segments

b) Application of epoxy paste

c) Jacking of central strand P1 and joint closing

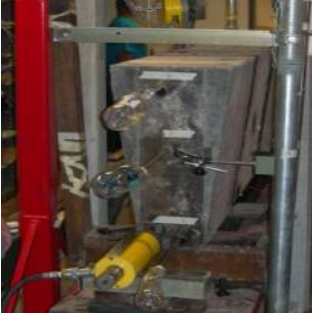
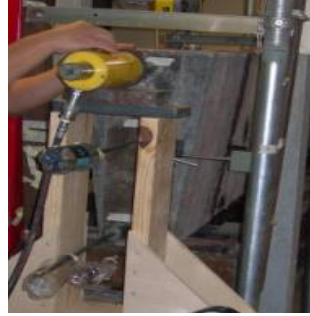
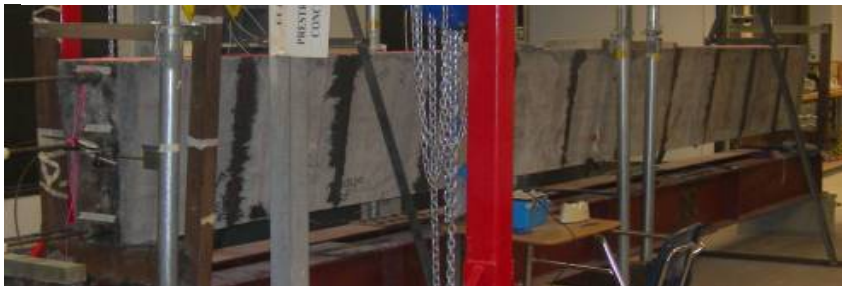
Figure 5. Postensioning of the segmental beam

After the epoxy cured, the beam was positioned on its end supports, proceeding to the jacking of the other strands according to a planned sequence. Figure 5 shows the jacking sequence and the resulting postensioned beam, which showed a horizontal misalignment of 0.75" at center, or 1/340 respect to the beam length.

a) Sequence of postensioning after the beam was positioned on its supports: Strand P2 until 28 kips, Strand P3 until 15 kips, and Strand P4 until 28 kips

b) Full postensioned segmental beam and final alignment error of 3/4" (Length/340)

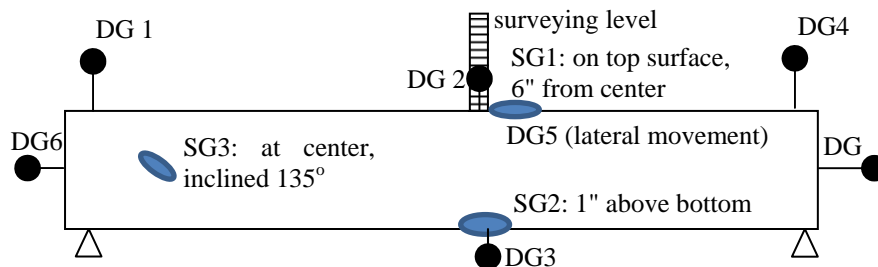
Figure 6. Sketch showing the dial gauges (DG) and strain gages (SG)

Figure 6 shows a sketch with the location of the instrumentation. The dial gauges DG1 to DG4 were used to measure the vertical deformation. The central movement was measured with redundancy using the dial gauges DG2, DG3 and the surveying level. The dial gauge DG5 was used to measure the lateral movement of the beam, and the dial gauges DG6 and DG7 were used to measure the shortening of the beam during the postensioning. The elongation of the cables was measured with a ruler.

The strain gage SG1 was located on the top surface and at 6" from the center, avoiding interference with the loading system. The strain gage SG2 was located at 1" from the bottom. Both strain gages, SG1 and SG2, measured the longitudinal strains at the center of the beam. The strain gage SG3 was located at 2'6" from the support, was inclined 135 degrees to the horizontal, and was used to measure the diagonal strain.

The beam was tested by applying a punctual load at the center of the beam using the hollow jack of 20 ton capacity. The diaphragm located at the center of the beam helped to avoid local failures due to the concentrated loading. The deformations and strains were measured using the instrumentation indicated in Figure 6. The theoretical deformations and strains were computed using the elastic properties of the concrete and considering the postensioning after the estimated losses. The deflections were computed using the following equation:

The critical stresses due to flexure were verified using the strain gages, SG1 and SG2, which were installed at the middle of the beam, and at top and 1" from bottom, respectively. The diagonal strain produced by the shear force was verified using the inclined strain gage SG3.

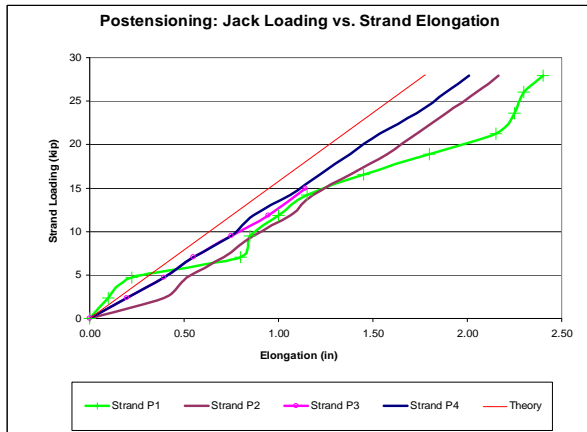
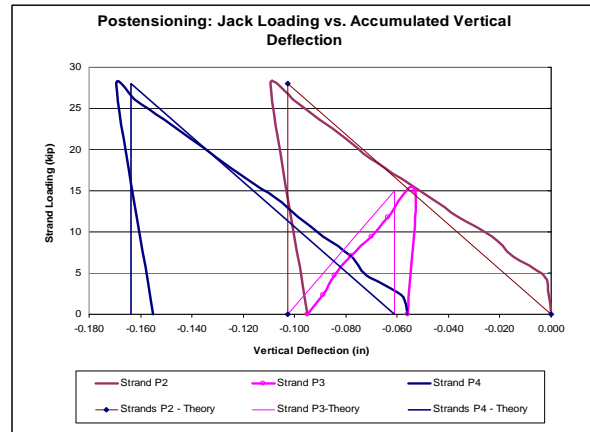
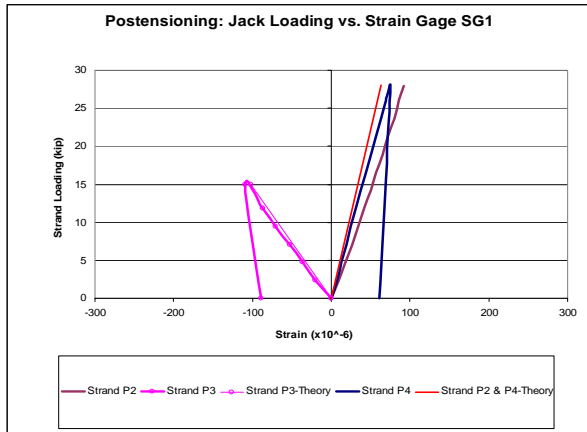
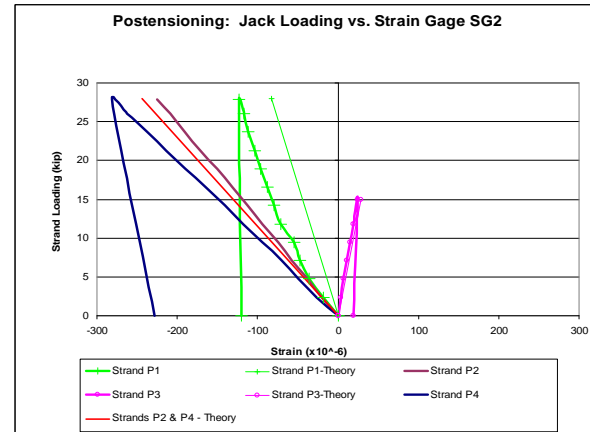
Figure 7. Segmental beam response during postensioning: cable elongation, accumulated vertical deflection, and strains at top (SG1) and bottom (SG2) of the central segment.

Figure 7 shows the response of the segmental beam during postensioning. The elongation of the strand 1 shows the maximum difference with the estimated value because the joints were closing. The elongation of the last strand is closer to the estimated value, with an error of about 12%. The elongation of the strands (Δ) was estimated using the following equation:

The strand P1 did not produced vertical deflection because it had no eccentricity. When the strand P2 was stretched the deflection of the beam was upward, which was reduced after jacking the strand P3, and again went upward after the strand P4 was jacked. Finally, the beam had an upward deflection like a camber of 0.17". The theoretical deflections had errors of 6% to 9%. The equation used to estimate the deflections (Δ_v) was:

Figure 7 shows the stresses measured by SG1 and SG2 for each jacking, which had an error between 6% and 33% respect to the calculations for the strains produced by the jacking of each strand. The joint movement, the beam misalignment, and internal interference protuberances of the epoxy paste may have influenced the errors. The calculations were done using the following equation:

The strains at the top surface (SG1) and at 1" from the bottom (SG2) of the beam center were measured during the postensioning. The strand P1 produced a uniform compression stress. The eccentricity of the strand P2 reduced the compression stress at top (SG1) and increased the compression stress at bottom (SG2). The strand P3 was needed to avoid excessive tension stress at top when the bottom strand P4 was fully loaded. The self-weight produced a bending moment that compressed the top and stretched the bottom.

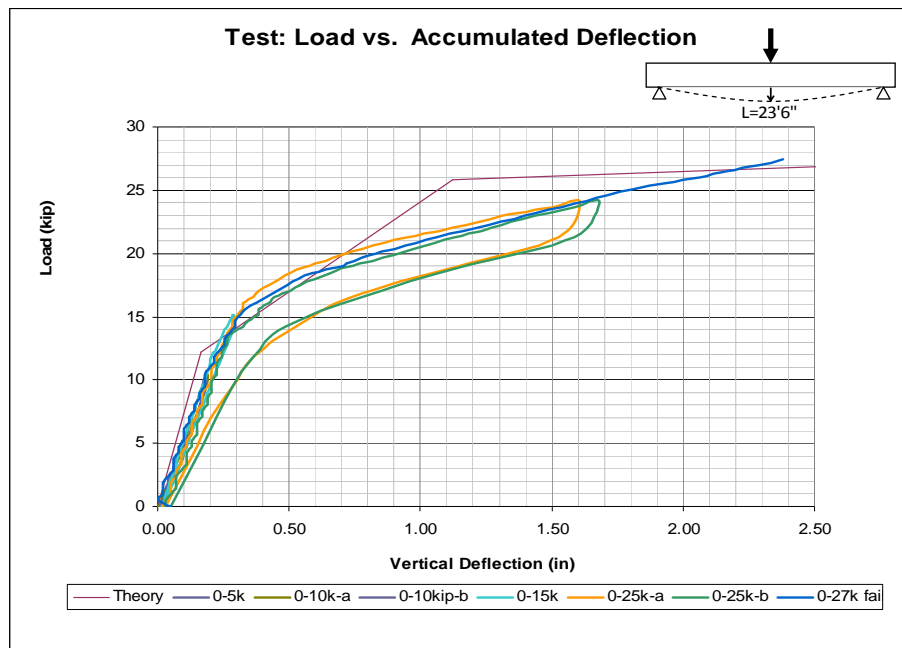
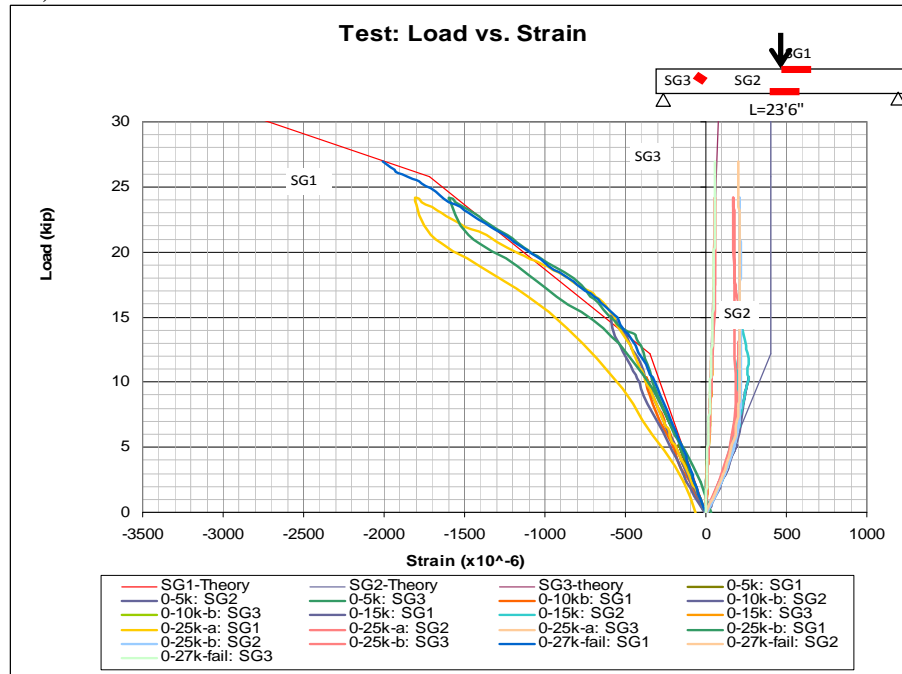
Figure 8. Deflections and strains during the segmental beam test

The load application was planned in order to observe the beam behavior prior to the first cracking, after cracking and at ultimate instance, defining 4 cycles of loading-unloading. Figure 8 shows the deflections and strains for the different cycles. The starting points for these curves don't consider the deflection and strains produced by the postensioning, which were zeroed before starting the test.

a) Accumulated deflections

b) Strain gage reading

The first loading was from 0 to 5 kips and then it was unloaded. The deflections and strains were very close to the elastic theory and returning to zeroes after unloading. The maximum deflection was 0.10".

The second load was from 0 to 10 kips, which was done twice with similar results. The maximum deflection for the load of 10.41 kips was 0.19" and after unloading the remaining deformation was 0.01". The maximum strain read by SG2 was 264 $\mu\epsilon$; by SG1, -375 $\mu\epsilon$; and by SG3, 33 $\mu\epsilon$. The strain gage SG2 did not increase its reading after a load of 7 kips. All the strain gages returned to zeroes after unloading.

The third loading was from 0 to 15 kips. The deflections were very close to the theoretical obtained from the elastic equation; however, the theoretical cracking load of 12 kips was not observed, being linear during all this loading. The deflection for a load of 15.14 kips was 0.291", and it was negligible at unloading. The strain gage SG2 followed the curve obtained in the previous loading cycle, and started to reduce after 11.35 kips, which corresponds to the aperture observed of the central segment joint. After the theoretical cracking load it was observed that the strain gage SG2 remained constant. The maximum reading of SG2 was 268 $\mu\epsilon$, going to zero after unloading. The maximum reading of SG1 is -586 $\mu\epsilon$; and -12 $\mu\epsilon$ after unloading. The strain gage SG3 registered a maximum of 48 $\mu\epsilon$ and zero for unloading, matching well with the theoretical results.

The fourth loading cycle was from 0 to 25 kips, which was done twice. Initially, the curves were similar to the previous load cycles, observing a strong change after the bottom of the segments started to crack. The cracks started to be visible after 15 kips, which corresponded to the load that produced cracks assuming a concrete tension capacity of 400 psi. The joint opening started to be visible at 13.7 kips, reaching a maximum aperture of 9 mm for 24.1 kips. Small concrete cracks in the anchor blocks were observed. Theoretically, the strands are taking forces close to their yielding increasing the bursting forces in the anchor blocks and therefore in the internal reinforcement, which worked properly.

The deflections followed the curves obtained in the previous loading cycles with a notorious change of stiffness at 15 kips. The maximum deflection was 1.65" for 24.1 kips and it returned to 0.02" after unloading.

During the fourth loading cycles the strain gages followed the curves obtained in previous cycles. The maximum strain read by SG2 was $218 \mu\epsilon$ for a load of 9.93 kips. The reading remained constant during the loading and returned to $12 \mu\epsilon$ at zero-load. The strain gage SG1 had a maximum reading of $-1599 \mu\epsilon$ for 24.1 kips and $-68 \mu\epsilon$ for zero-load. The strain gage SG3 provided linear reading from 0 to 20.3 kips, with a maximum strain of $56 \mu\epsilon$ and remaining constant for greater loads. The SG3 returned to zero after unloading.

Finally, the beam was loaded from 0 to 27.43 kips, whereby the failure of the top concrete layer became present. The deflection curve followed the previous curves. The maximum deflection was 2.38". The strain curves also followed the previous curves. The strain gage SG2 had a maximum reading of 213 $\mu\epsilon$, remaining almost constant from 8 kips. The strain gage SG1 had a maximum reading of -2011 $\mu\epsilon$ at failure. The strain gage SG3 is very linear and the maximum reading was 55 $\mu\epsilon$ for 23.65 kips, remaining constant after this load.

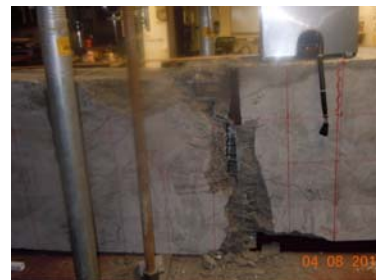
Figure 9. Failure during test

Figure 9 shows the joint opening and failure of the central hollow segment. It is observed that the epoxy paste does not resist tension, there are several diagonal cracks starting from the loading plate and having a 45° path, and the final failure is due compression crunch of the top layer of concrete. The nominal ultimate load was 31 kips, obtained using the ultimate strain of 3000 $\mu\epsilon$, given by ACI 318-08, and assuming the strands were parallel to the bottom of the beam. However, the maximum strain read was 2011 $\mu\epsilon$, which was added to the strain due postensioning of 45 $\mu\epsilon$, having a total strain of 2056 $\mu\epsilon$, at failure. Additionally, during the maximum loading the bottom strands were not parallel to the beam and they must be touching the central diaphragm; therefore, the effective depth "d" should be reduced by approximate 1". Using these values, the theoretical maximum load was closer to the load producing failure.

a) Joint aperture

b) Central segment after failure
