Observational Study of Centerline Rumble Strips in Puerto Rico: PR-114 Case Study

13th LACCEI Annual International Conference: “Engineering Education Facing the Grand Challenges, What Are We Doing?”
July 29-31, 2015, Santo Domingo, Dominican Republic **ISBN:** 13 978-0-9822896-8-6 **ISSN:** 2414-6668
DOI: <http://dx.doi.org/10.18687/LACCEI2015.1.1.282>

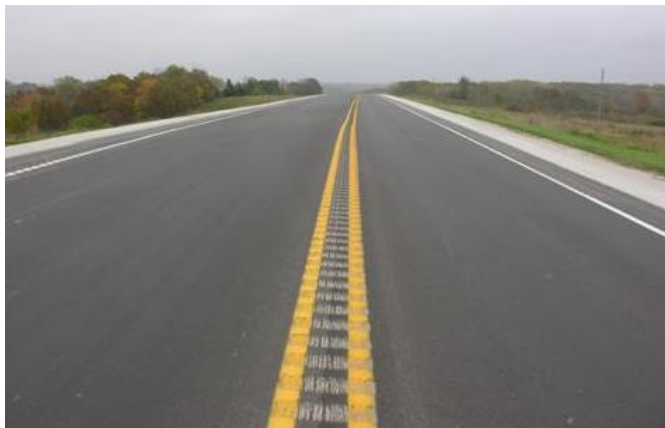
Fig 1 Example of CLRS, Source: safety.fhwa.dot.gov

There are 4 different types of CLRS: formed, raised, rolled, and milled, being the most commonly used. These CLRS are designed similarly to shoulder rumble strips, in which the grooves milled along the centerline cause vibration and noise alerting the driver to get back into their travel lane,

Fig. 1. Before this safety measure is further implemented, it is important to see if this countermeasure is effective on Puerto Rico's highways which have distinct characteristics when compared to most of the United States roads where the CLRS have been previously installed and tested.

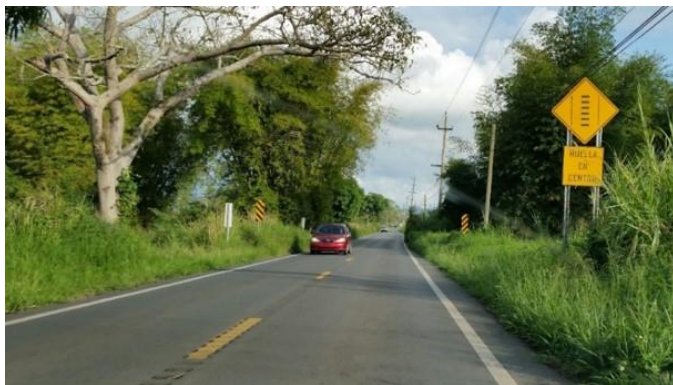
Fig 2 Cross-section of PR-114 Kilometer 12.1 Eastbound

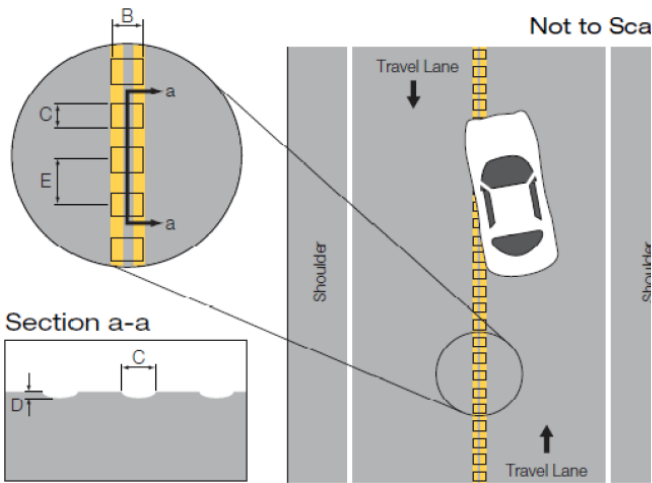
Fig. 3 CLRS Dimensions, Source: FHWA

It would be ideal to standardize the use of CLRS in respect to rumble pattern, dimensions, ADT, lane width, pavement age, pavement depth, area type, and speed limit. In an attempt to achieve this, a comprehensive study was performed looking into the states where the CLRS have been implemented, the type of CLRS used, the rumble dimensions, and whether the state had a policy or a standard. In the 2003, 27 out of the 50 states surveyed responded, and out of the 27 states, all used milled CLRS, and 9 had a CLRS policy. The rumble strip dimensions are defined in Fig. 3, a guide provided by the FHWA to help create consistency [5].

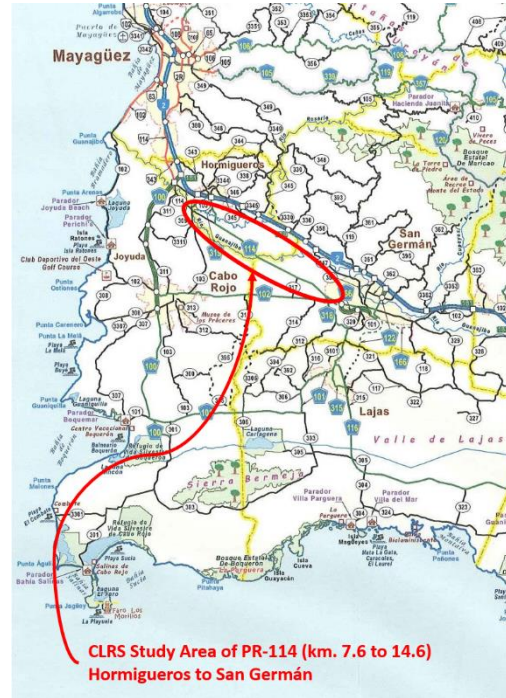
Fig. 6 PR-114 Study Area – Km 7.6 – 14.6 Hormigueros to San Germán, PR

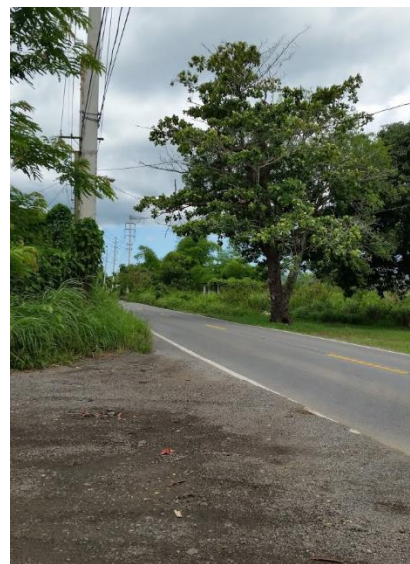
Fig. 7 Unpaved Driveway View from Driver's Line of Sight, Km 9.5

sewer authority facilities. Approximately 90 percent of these driveways were unpaved and several were located within a horizontal curve which creates a potential hazardous condition especially in the case where a vehicle needs to accelerate from the driveway to the main highway. There was a variability in driveway widths, paved versus unpaved, and level of illumination in the vicinity of the driveway. Fig. 7 depicts an unpaved driveway with limited sight as a result of high roadside vegetation and a utility pole.

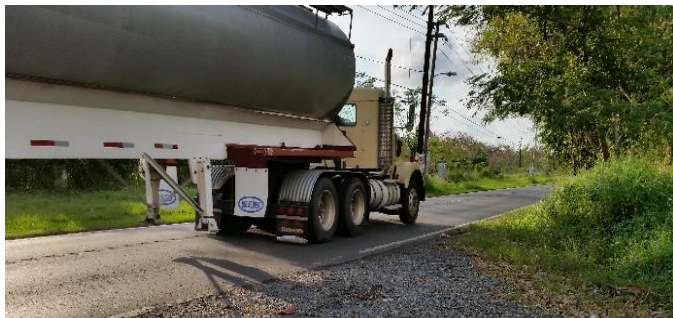
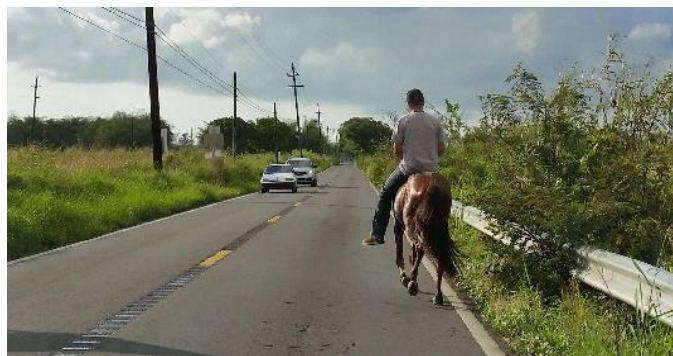
Fig. 8 Road User Mix

a) Tractor Semi-Trailer Tanker Truck with 350 Ton (10,000 Gal.)

b) Equestrian

This route contains a high volume of vehicles within the morning of the week days for several reasons. The roadway offers linkage between the four municipalities mentioned to a mix of road users such as: passenger cars, SUVs, motorcycles, equestrians, cyclists and heavy vehicles. Examples of road users other than passenger cars that are frequently found on the highway are shown. Fig. 8a and 8b depict examples of road users other than passenger cars that are frequently found on the highway.

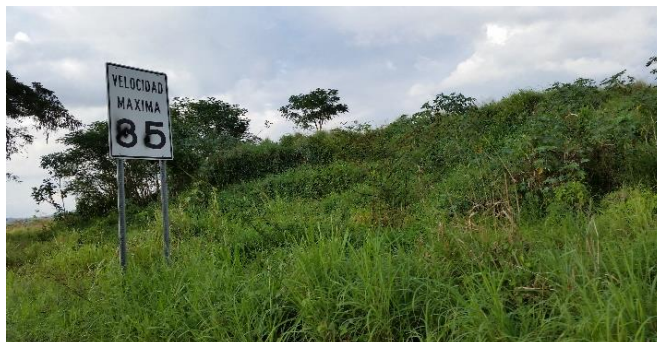
Fig. 9 Speed Limit Sign Vandalism along PR-114.

not obeyed with over 50 percent violations observed in the study period. The disregard to the speed limit is also evident in the number of vandalized posted speed limit signs. An example is shown in Fig. 9 where the sign was spray painted to show an “86” miles per hour speed limit. One can conclude that users disagree with the posted speed limit.

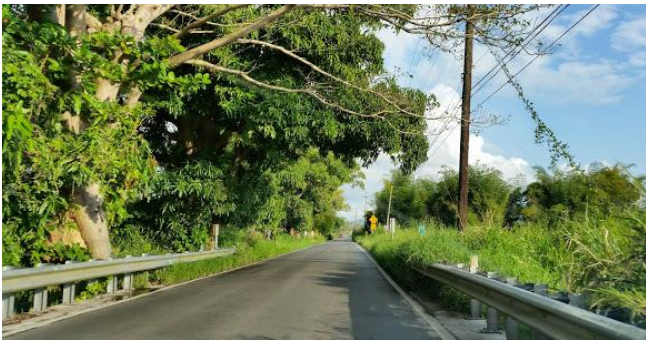
a) Narrow Bridge Km. 12.0 Eastbound

The segment is a rural two-way, two-lane segment with an estimated lane width varying from 2.75 to 3.05 meters (9 to 10 feet) with unpaved or narrow shoulders. There are five bridges, two of which are narrow bridges without prior warning signage and no centerline dividing each lane since each lane width is less than 2.75 meters (9 feet). The narrow bridge located on kilometer 12.0 can be seen depicted in Fig. 10a. The change in lane width can be appreciated when compared to the cross section in Fig. 10b. Fig. 10c provides a cross section along a horizontal curve on PR-114.

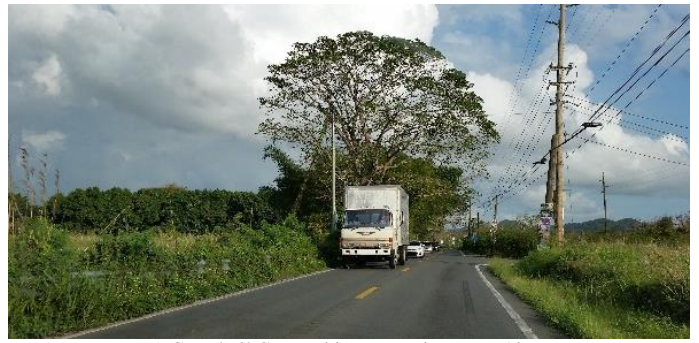
a) Guardrail Covered in Vegetation, Km. 12.7

Approximately a total of 550 meters (1,805 feet) of strong post guardrails were installed non-continuously and are found along narrow bridges and certain segments where the lateral slope or other hazardous fixed objects are located. Based on the observations, the majority of the guardrails were covered with vegetation, as shown in Fig. 11a, as well as signs, Fig. 11b, and fire hydrants. The roadside vegetation consisted of a tall grass and bamboo, vines, and trees. The trees and bamboo have managed to create a canopy along several portions of the roadway, Fig. 11c.

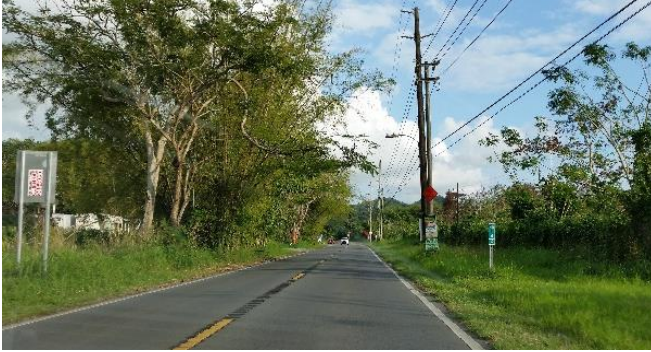
b) Cross Section Km. 14.4 Eastbound

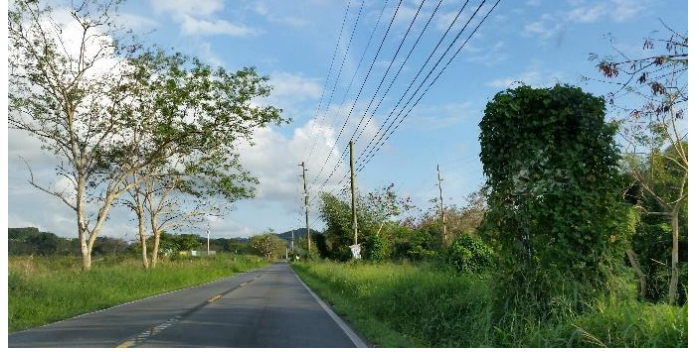
b) Speed Limit Sign Covered in Vegetation Km. 13

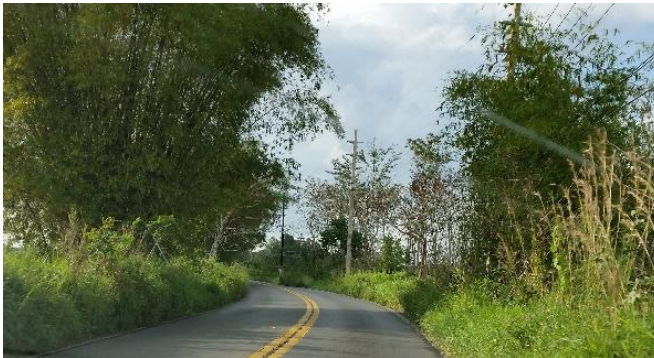
c) Cross Section on Horizontal Curve Km. 9.1 Westbound

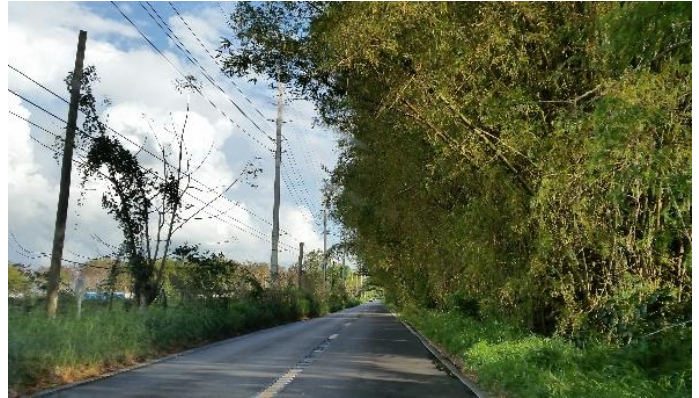
c) Tall Bamboo & Grass Km. 9.2

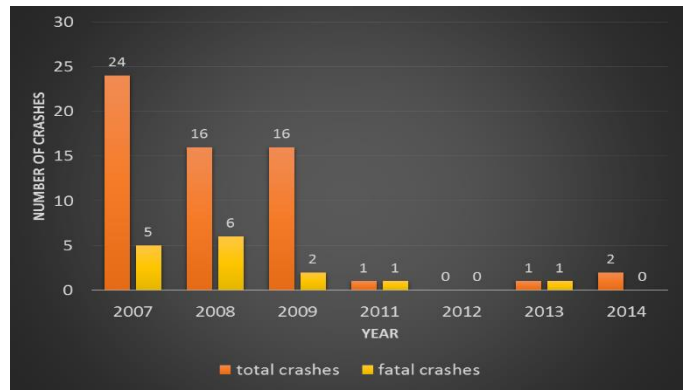
Fig. 12 Total & Fatal Crash Statistics Within Treated Segment of PR-114, Data Source: Mayagüez Regional Police Crash Reports

Although the CLRS safety treatment has been in place for less than two years' time, there has already been a reduction in fatal and total crashes. It is possible that the CLRS are not fully responsible for the reduction, due to other possible contributing factors, but it can be concluded that there is a reduction since 2007. The crash statistics including total crashes and fatal crashes are depicted in Fig. 12.
